# PROPERTY INSPECTION REPORT

1234 Nowhere Ave SW, Calgary,

*DATE OF INSPECTION: 8/3/2023*

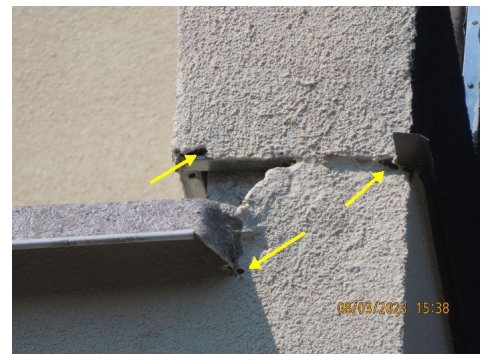
- Missing stucco observed with gaps present, suggest repairs as necessary.
- Poor finishing noted.
- Location: rear

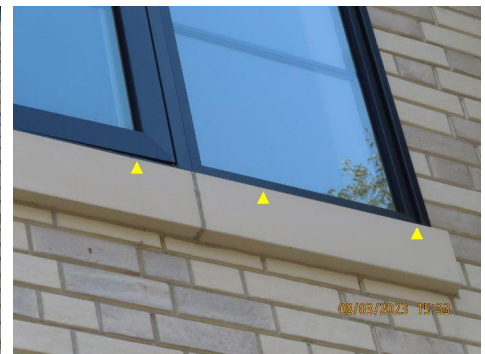
Front; window drip flashing installed too short - should extend past the lower trim for effective drainage. Repair is advised.

Front; drip flashing at bottom installed too short; should extend past the lower window trim for effective drainage.

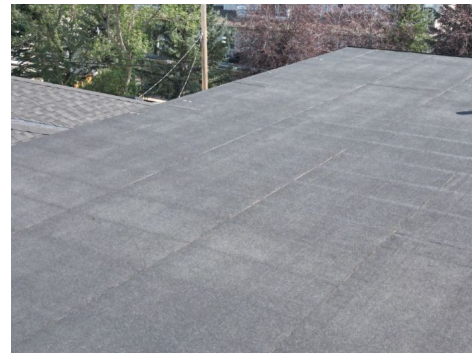
- **CONDITION:** There are no downspouts installed on the roof; No drainage gutters installed for roof drainage observed.
- \* Recommended further evaluation and necessary repair / improvement by a qualified contractor.

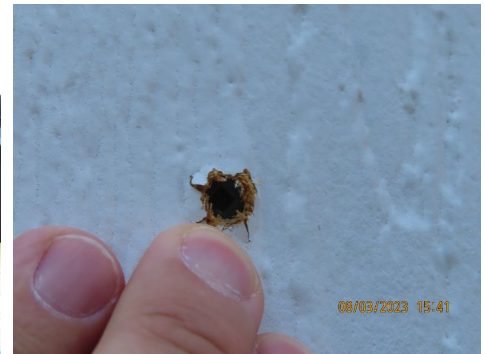
- The exterior cladding has minor holes/screws noted. Recommend repairs to prevent additional damages.  
\*Seal all screw heads

Recommend sealing gaps on exterior to prevent larger insects/moisture from penetration

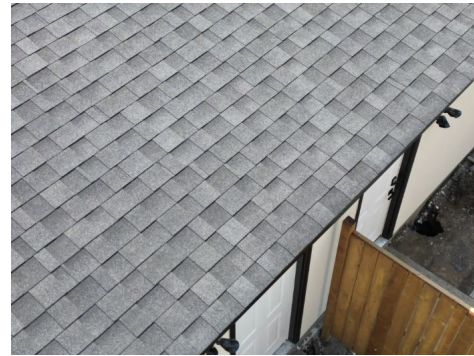
- **CONDITION:** Missing gutters/ downspouts observed. Suggest downspouts be installed to ensure proper drainage away from the foundation. Moisture related issues to roofing edge, siding, water damage/intrusion, as well as foundation related problems can occur. Recommend installation to gutter by qualified contractor.

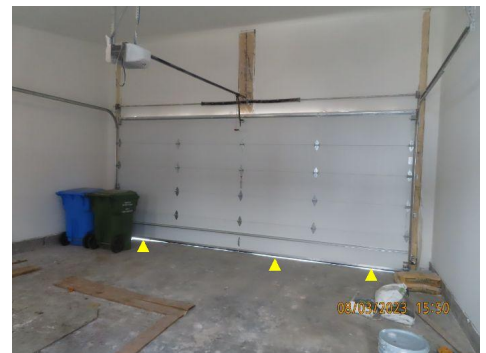
- Voids space seen at bottom where concrete meets weatherstripping on door due to concrete pad cracks/uplifting condition.
- \*Recommend adjustment of opener to close gap at bottom.
- Weatherstripping is damaged, recommend replacement, as necessary.

Damaged weatherstripping  
recommend replacement

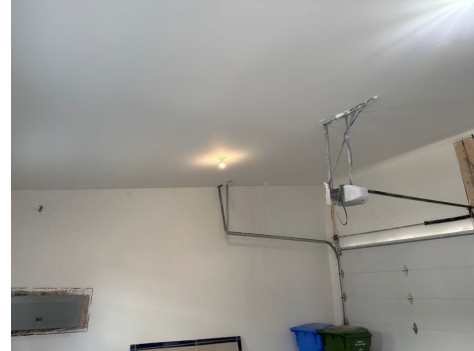
\* Suggest sealing all area that have gaps to maintain fire rating of this wall.

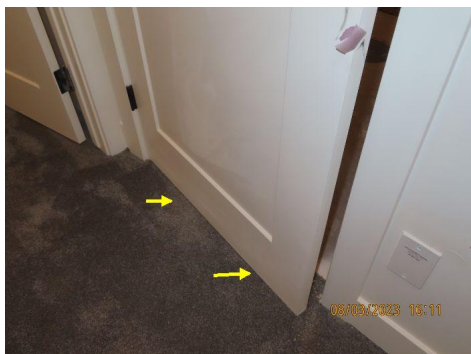
Furnace door rubs against carpet; recommend trimming back 1/2" inch for clearance

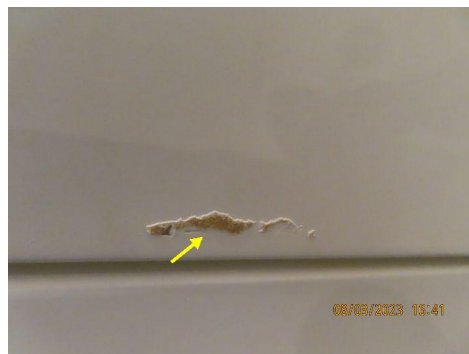
Damaged surface at basement built in - recommend repairs

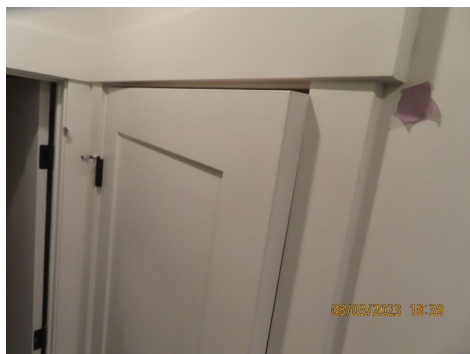
Basement; furnace room; not closing properly. Missing screws in hinge not installed. Repair advised.

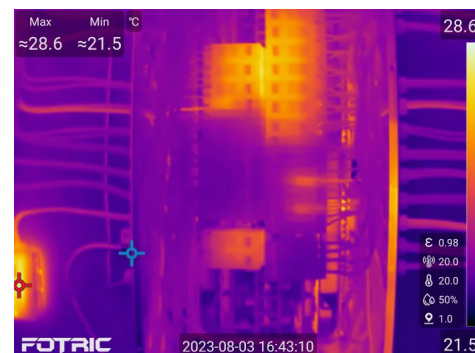
Page 39 Item: 3	Main Panel Comments	<ul style="list-style-type: none"> <li>• <b>CONDITION:</b> Oversized wiring for the circuit is considered a safety hazard and should be repaired by a licensed electrician.</li> </ul>
-----------------	---------------------	--

- **CONDITION:** Oversized wiring for the circuit is considered a safety hazard and should be repaired by a licensed electrician.

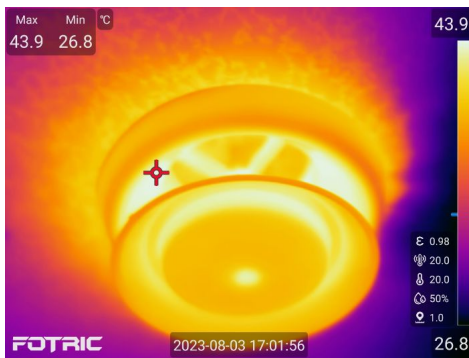
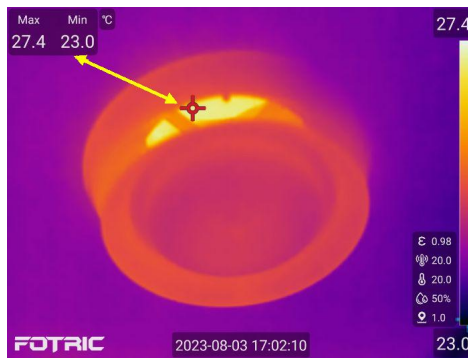
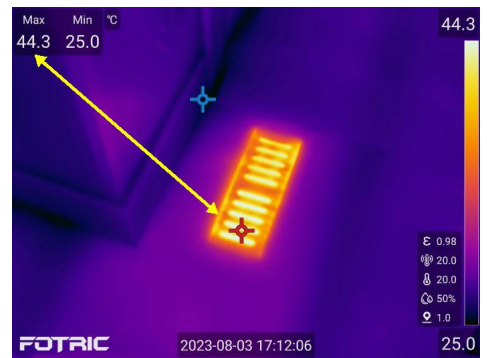
\* location: basement/ ceiling duct next to gym area.

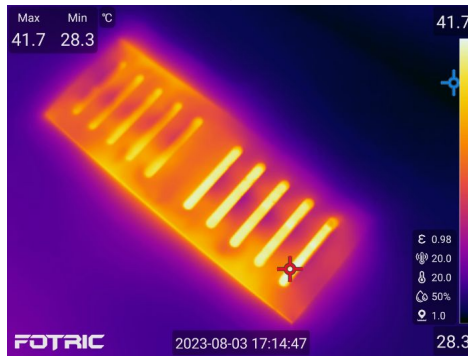
CONDITION: Poor air flow or functional heat was observed at this heat delivery resistor. Recommend immediate further investigation and repairs by an HVAC contractor prior to lifting your inspection conditions.  
\* location: basement/ ceiling duct next to gym area.

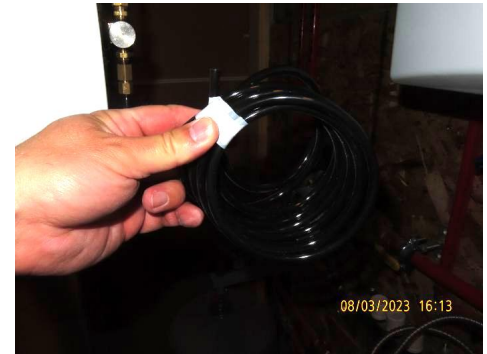
\* Water supply line is not connected. Humidifier not operational

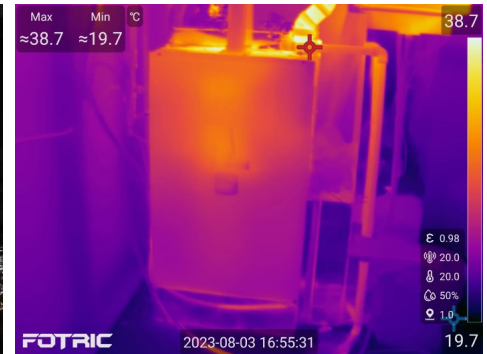
Multi Zone In-Floor Radiant Heating plumbing present in basement.  
Condition: NO seperated water tank to supply in floor radiant hearing.  
\*Recommend reviewing current setup with builder as this system is not completed.

Multi Zone In-Floor Radiant Heating plumbing present in basement.

Condition: NO seperated water tank to supply in floor radiant hearing.

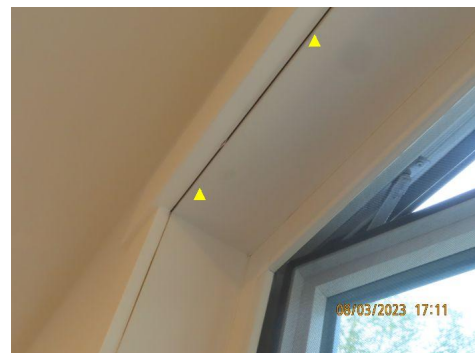
\* Gaps around window trim work observed.

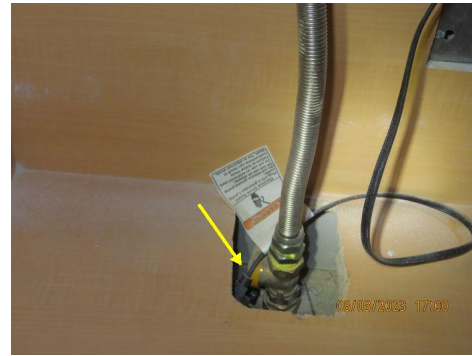
Difficult to rear the gas shutoff! Recommend repairs for safety.

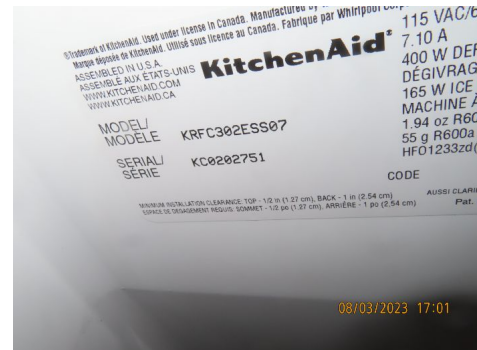
\* Appliance not plugged in/powerd up during inspection.

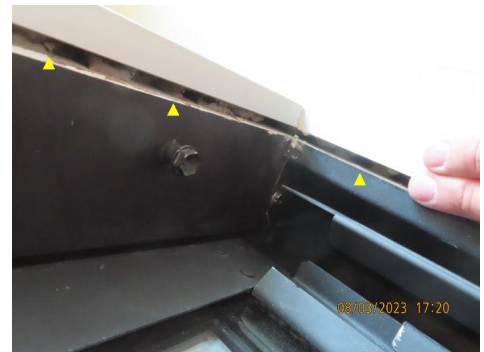
- Not serviceable at time of inspection. Recommend confirming operational prior to possession.
- Pilot light "off" at time of inspection. Lighting of pilot lights is not within the scope of inspection. Buyer is therefore urged to ensure satisfactory operation of this unit prior to close.
- \*Recommend sealing gaps around fireplace
- **CONDITION:** Gaps at top/ around fireplace were observed; Recommend completion.

**CONDITION:** Gaps at top/  
around fireplace were observed;  
Recommend completion.

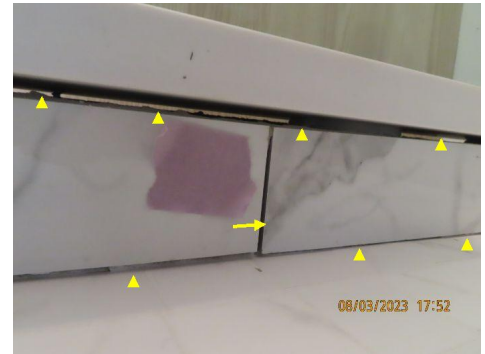
2nd floor en-suite bath; shower base

2nd floor ensuite bath: Missing grout/silicon glue seal

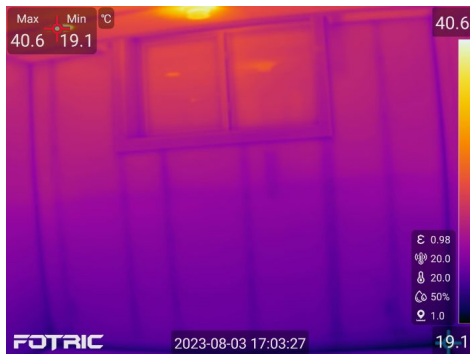
\* Location: 2nd floor front bedroom - left side of window. Further review is advised.

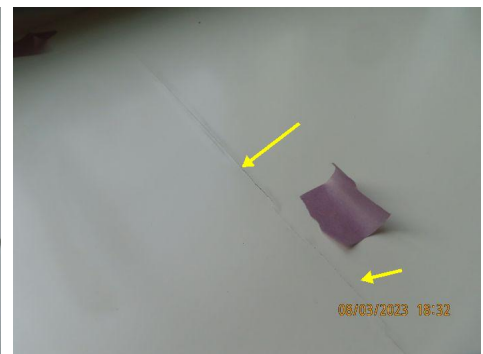
Master bedroom - window drawer - not closing flush

Master bedroom; seams on finishing observed; repair advised
