# PROPERTY INSPECTION REPORT

1234 Nowhere Ave SW, Calgary,

*DATE OF INSPECTION: 8/3/2023*

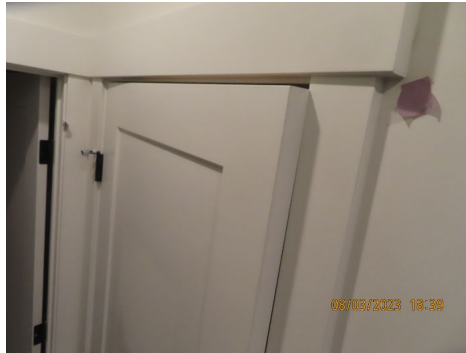
Basement; furnace room; not closing properly. Missing screws in hinge not installed. Repair advised.

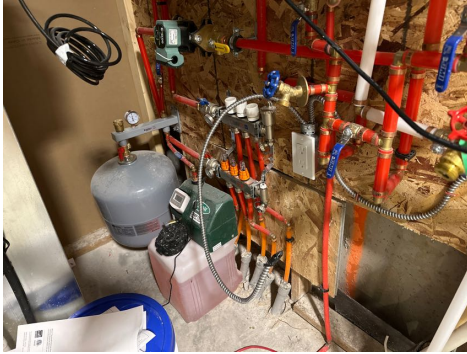
Multi Zone In-Floor Radiant Heating plumbing present in basement.  
Condition: NO seperated water tank to supply in floor radiant hearing.  
\*Recommend reviewing current setup with builder as this system is not completed.

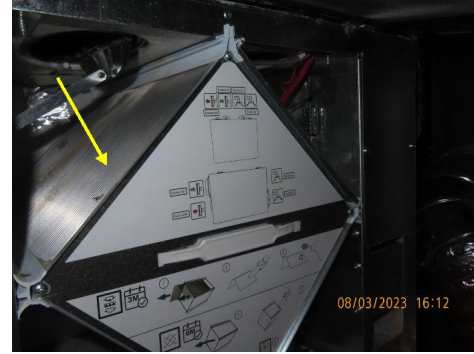
HRV - Missing one filter/ not installed - recommend installation

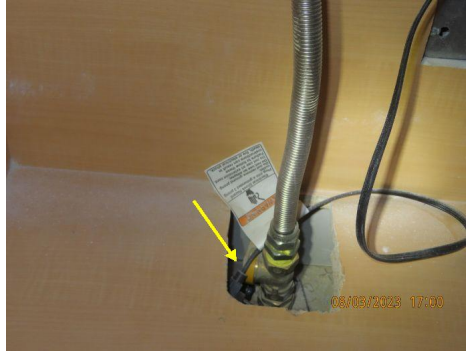
Difficult to rear the gas shutoff! Recommend repairs for safety.

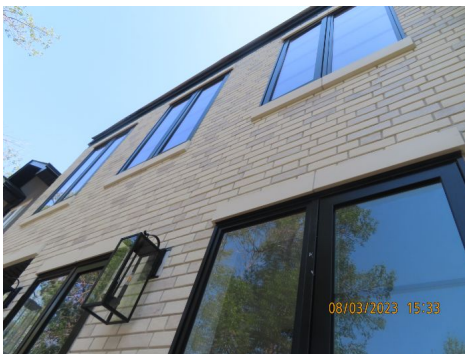
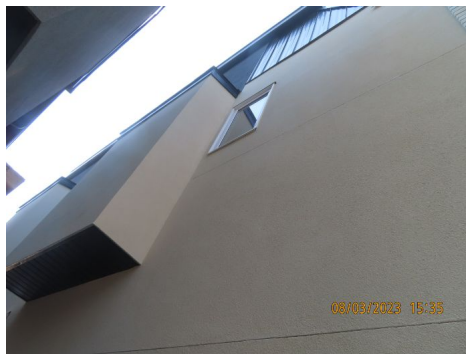
- Missing stucco observed with gaps present, suggest repairs as necessary.
- Poor finishing noted.
- Location: rear

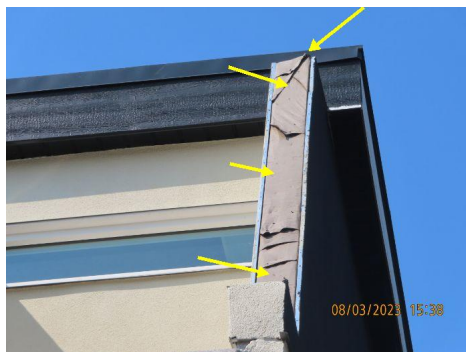
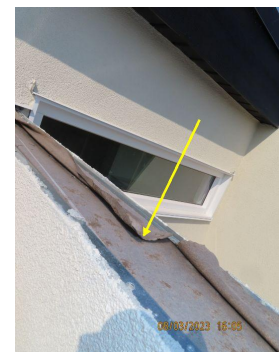
- Recommend review by a qualified professional for repair or as necessary prior to possession.
- Location: rear missing stucco finishing at deck.

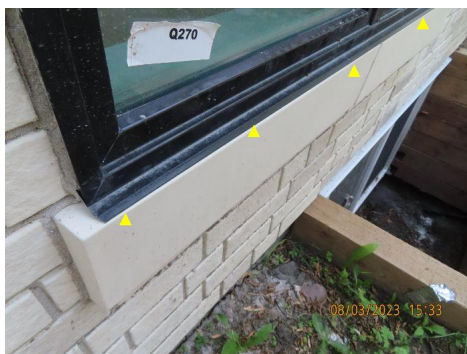
Front; recommend repair; drip edge too short; should extend past window trim for proper drainage.

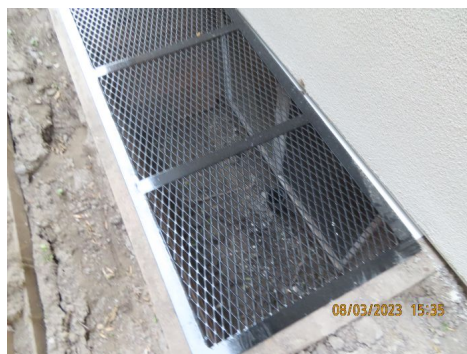
Exterior window covers are not secure and move; recommend review by builder to ensure safety.

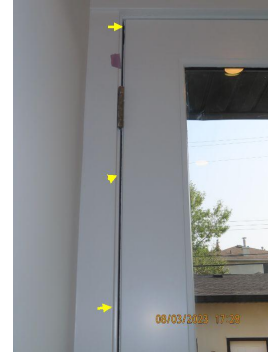
Rear exterior door to deck; recommend review for better fitting/ larger gap at top of door compared to lower.

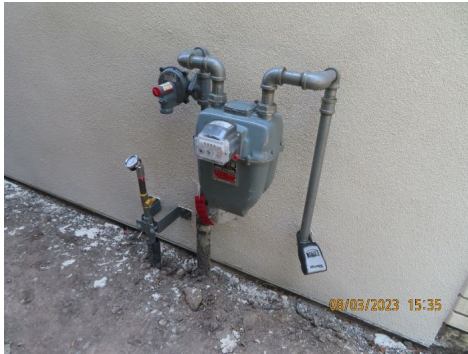
- Any exterior gas lines/ appliances including but not limited to gas grilles/ BBQ's/ lighting etc. are not operated. As per CAHPI Standards of Practice.
- Added gas lines observed at the meter . These lines appear to be improperly installed. This is a possible safety hazard. Suggest further review by a qualified plumber or local gas company prior to closing to ensure the proper and safe installation of these gas lines.

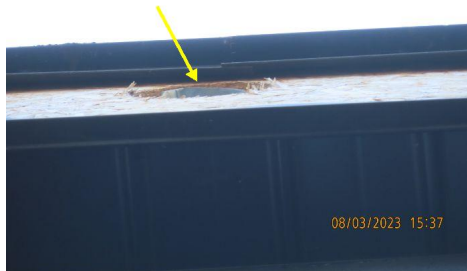
- Vent covers damaged/missing. Recommended for replacement/repairs.**

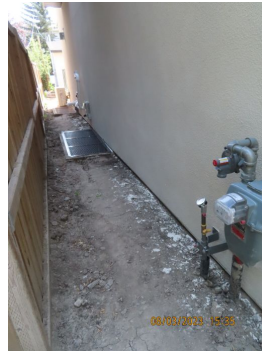
Dips around garage; recommend topping of to prevent pooling water at garage exterior

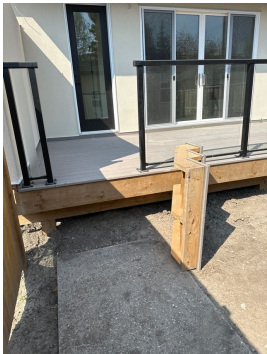
- **CONDITION:** Deck stairs not installed at rear deck
- \* Recommend review at walkthrough prior to possession.

Rear deck stairs not installed at time of inspection.

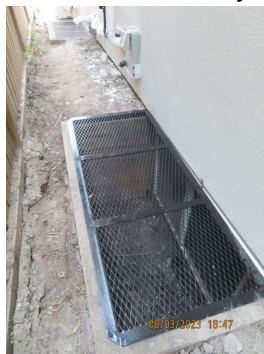
Loose window covers noted; moving around; safety. recommend securing appropriately

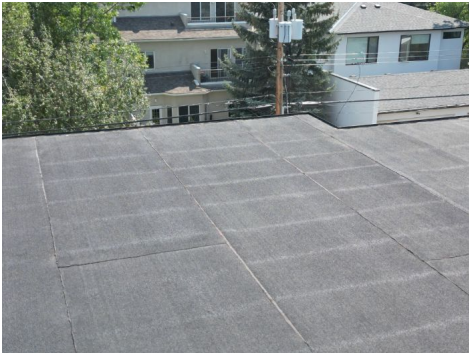
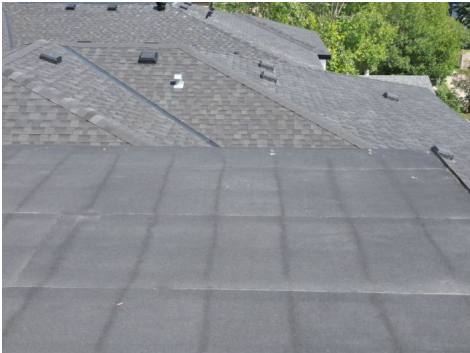
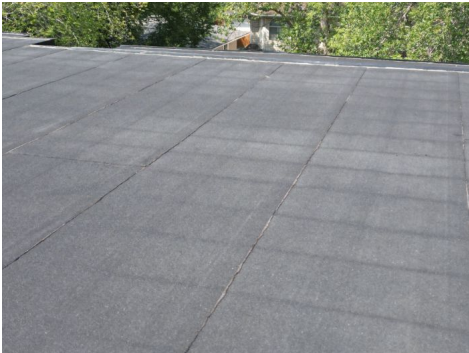
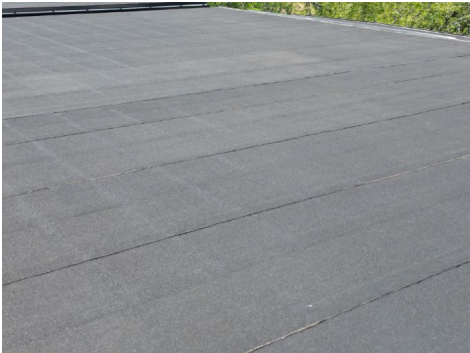
Observations:  
• Roof shows normal wear for its age and type. No damaged, deteriorated, or missing roofing materials were observed; it appears to be in serviceable condition.  
• Leakage not always is detectable, Sometimes it need certain weather condition for the leakage to show up. Recommend you "the client: to find out from the seller if the source of the leakage has been repaired by a qualified contractor or not? or to have further investigation and necessary repair by a qualified contractor if needed.

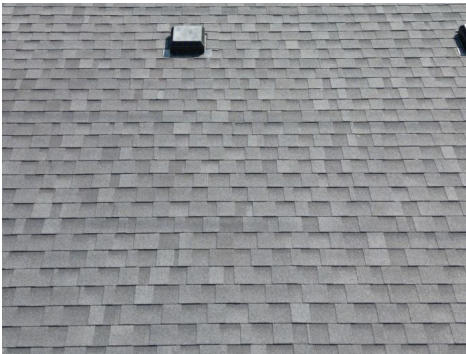
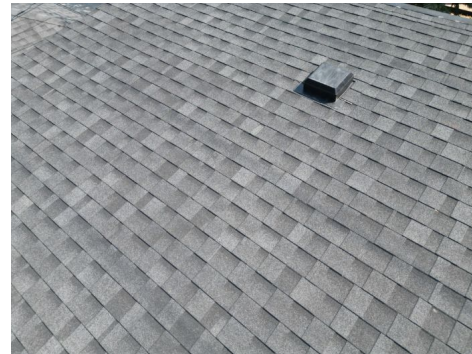
- The garage roof is the same as the house and appears to be the same age.

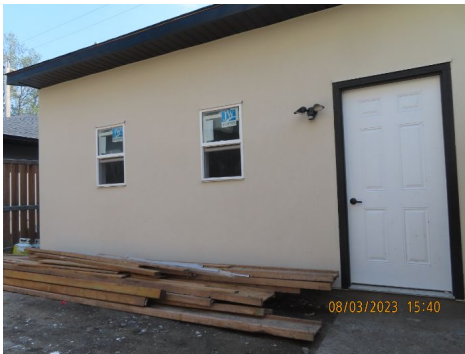
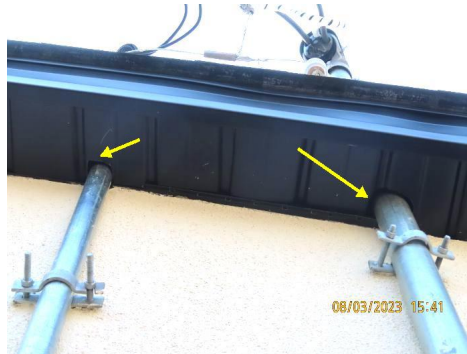
- The exterior cladding has minor holes/screws noted. Recommend repairs to prevent additional damages.  
\*Seal all screw heads

Recommend sealing gaps on exterior to prevent larger insects/moisture from penetration

Seal all penetrations on exterior as recommended

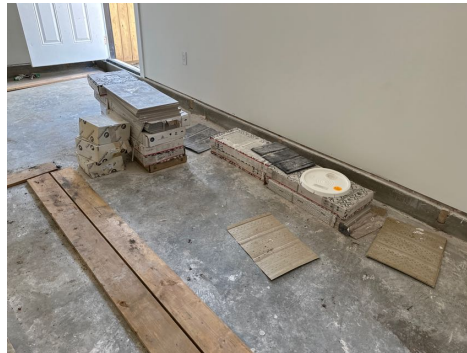
- Garage floor is in good serviceable condition and sloped towards doors for diverting water out of the garage.

Builders tiles on flooring

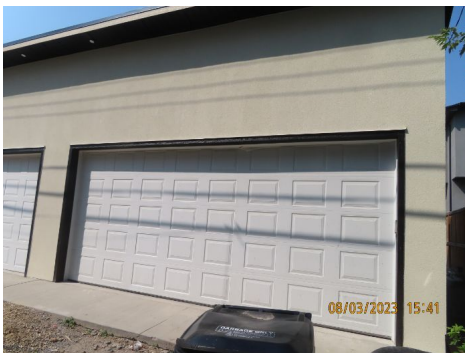
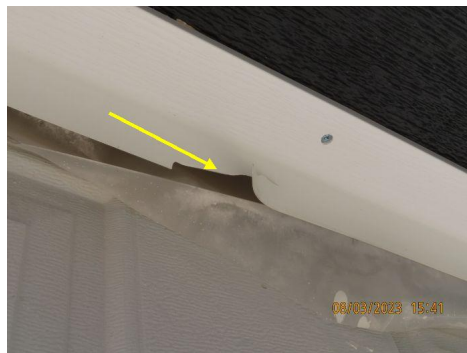
- Voids space seen at bottom where concrete meets weatherstripping on door due to concrete pad cracks/uplifting condition.
- \*Recommend adjustment of opener to close gap at bottom.
- Weatherstripping is damaged, recommend replacement, as necessary.

Damaged weatherstripping  
recommend replacement

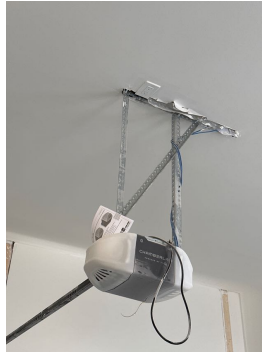
- Door opener is disconnected, did not test  
Recommend testing prior to possession.

Disconnected

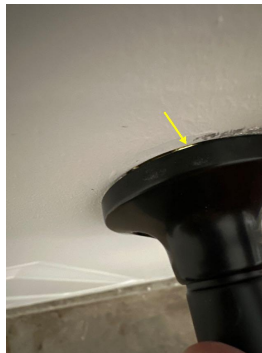
- Recommend review for repair or replacement as necessary.  
Gaps around door lock observed. Door lockset is small and hole cut seems too big.

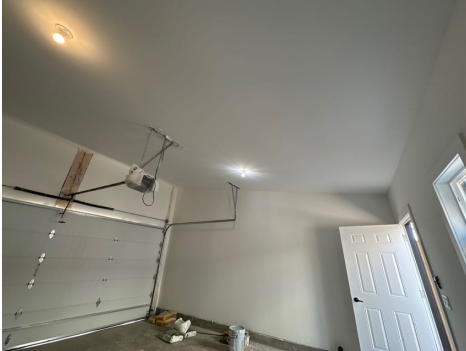
- Dry at the time of the inspection. No stains or moisture penetration was observed during inspection with infrared thermography. No visible gaps or damages were observed. Garage walls were insulated.

\* Suggest sealing all area that have gaps to maintain fire rating of this wall.

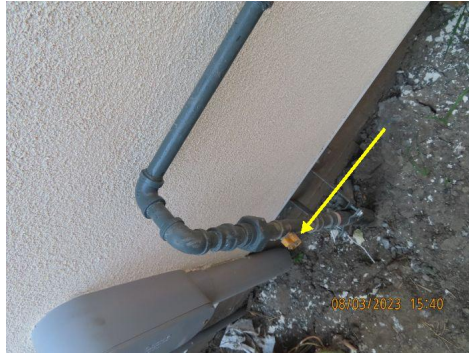
Additional gas line fitted for future gas space heater.

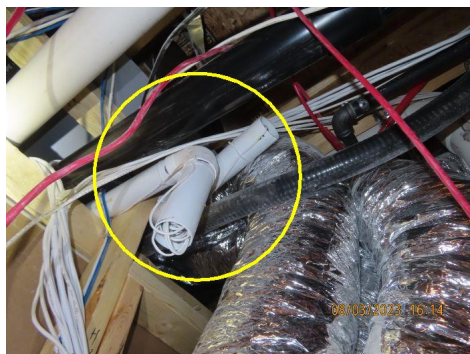
Roughed in Central Vac

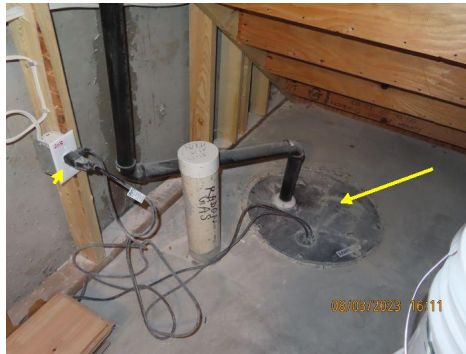
**CONDITION:** Recommend routing discharge away from foundation to reduce the chance of water re-entry.

Sump pump water discharging point was too close to the building; discharging water near the foundation could result in water penetration inside the basement. Water must be discharged at least 20 feet away from the building. Recommend to be repaired by a qualified contractor.

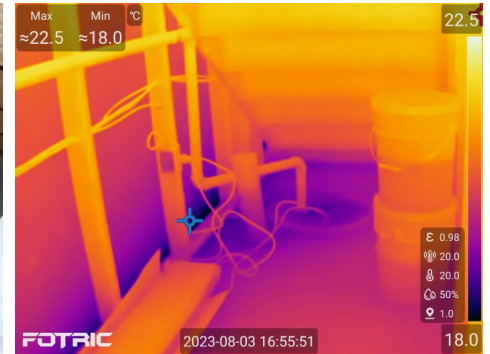
Rough in Radon pipe present;  
No radon test was completed during inspection

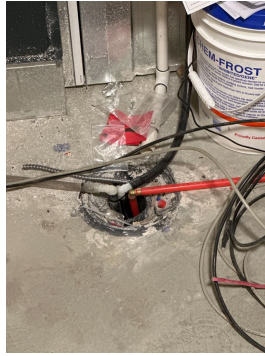
No cover drain installed, trip hazard.

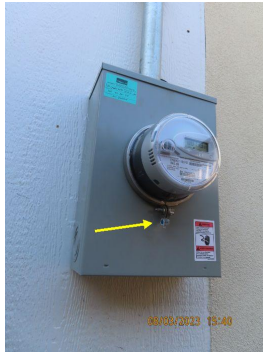
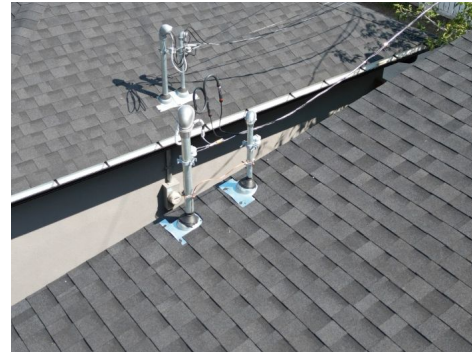
- Power company seal intact and not tampered with. The security tag ensures electrical tampering has not occurred.

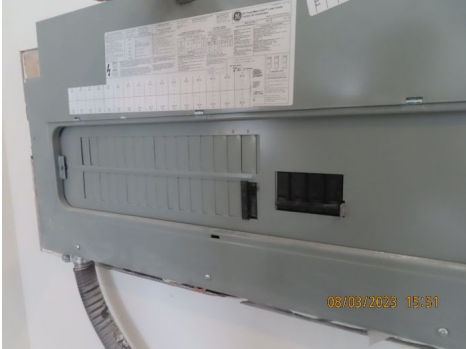
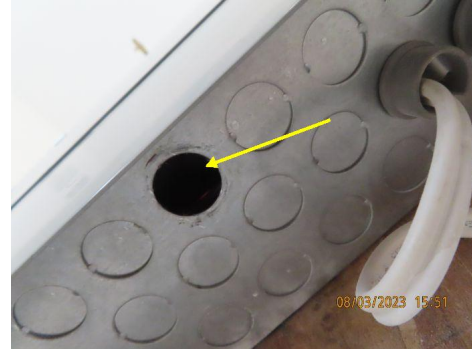
Missing panel plug; recommend installation for safety

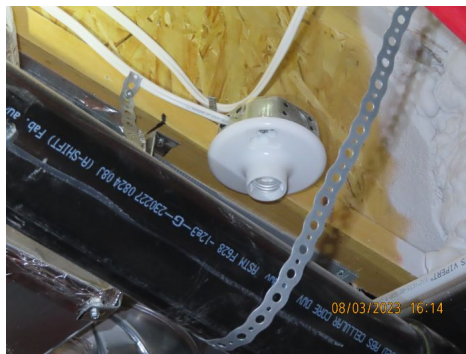
furnace room - no bulb installed - recommend builder install to prove fixture is operational

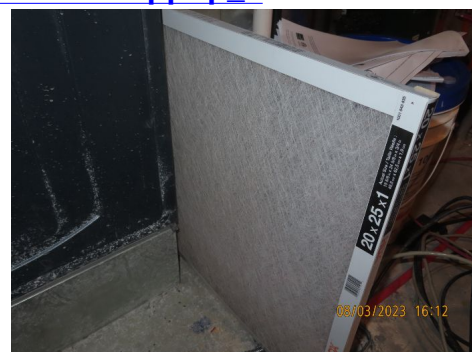
Condition: Furnace filter location and size. The arrow on the filter should point towards the furnace.

Failure to install the filter in the correct orientation can result in damage to the furnace fan.

Task: Replace,

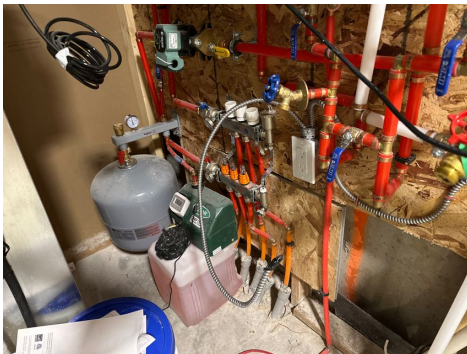
Multi Zone In-Floor Radiant Heating plumbing present in basement.

Condition: NO seperated water tank to supply in floor radiant hearing.

HRV - Missing one filter/ not installed - recommend installation

\*Recommend reviewing current setup with builder as this system is not completed.

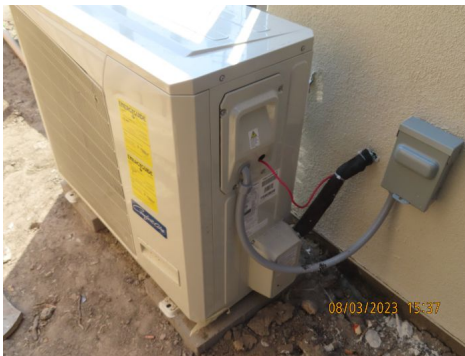
- Electrical disconnect provided near this unit for safety.
- **Recommend review by a licensed HVAC contractor for moving the unit away from exterior faucet as necessary, prior to close.**

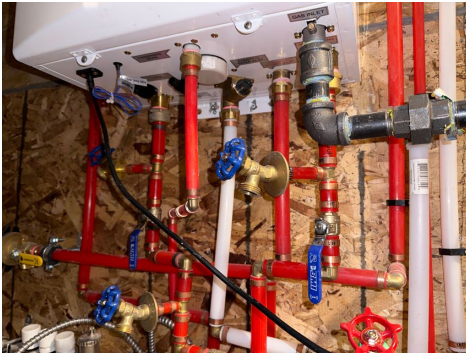
- No leaks observed at the time of the inspection.
- Recommend monitoring connections for corrosion and/or leaks.
- Hot Water shutoff valve present
- **CONDITION:** Unit off at time of inspection; unit not tested/no power.
- \* checked plugs/ breaker ON.

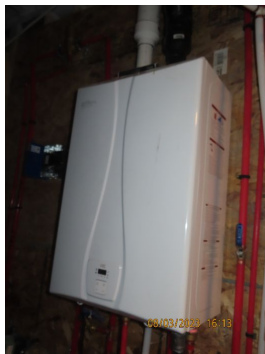
- **CONDITION:** Off at time of inspection; combustion operation not reviewed.

CONDITION: Off at time of inspection;  
combustion operation not reviewed.

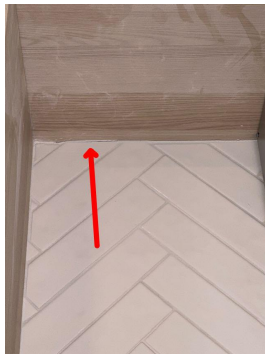
cracked grout/ gaps at top of tile setting. Repair is advised.

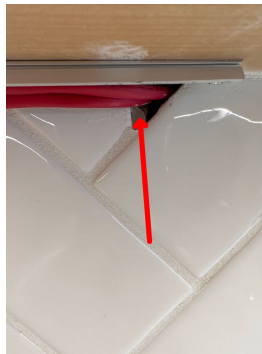
Gaps under cabinetry; should be grouted for finish

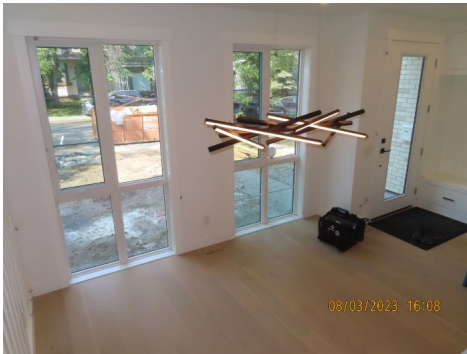
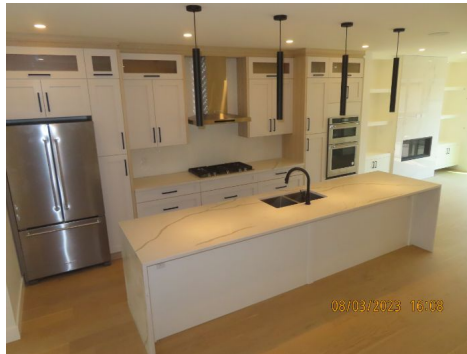
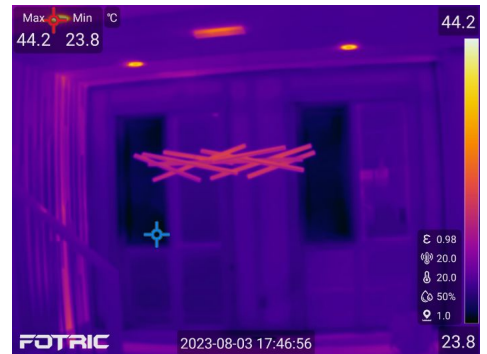
thermal: dining room

- Dry at the time of the inspection. No stains or evidence of moisture penetration \ were observed with infrared thermal camera at time of inspection.

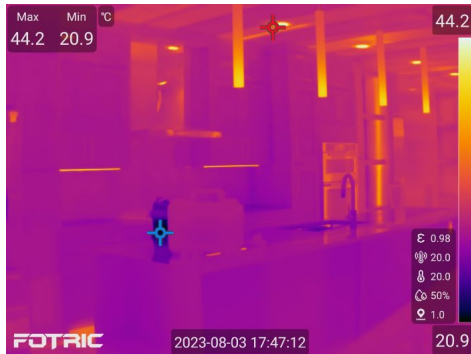
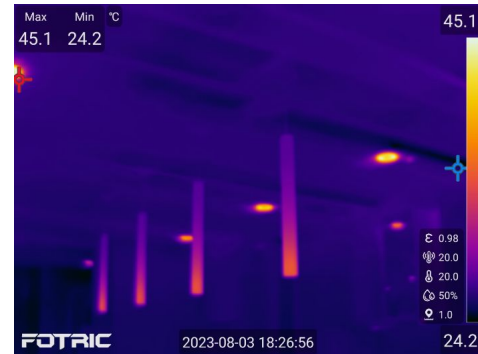
Thermal: ceiling/ dry

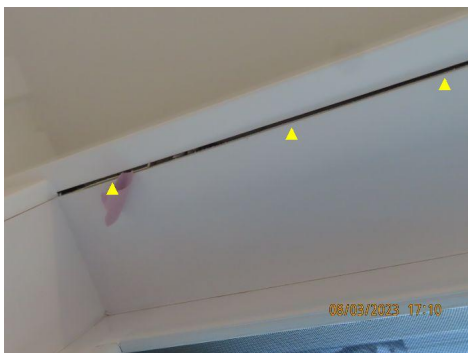
\* Gaps around window trim work observed.

- Recommended to use Silicone 100% to seal around prolong life on window frames.

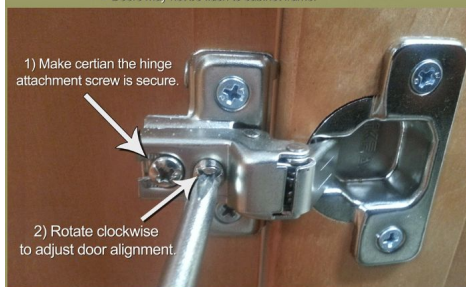
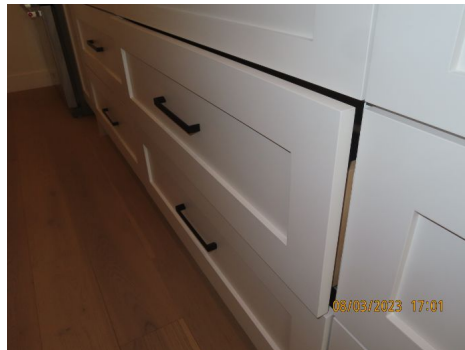
At stove area

- Doors may not be aligned properly.
- Doors may not be flush to cabinet frame.

Use screw 1 to adjust the doors from side to side. Turning the screw in a clockwise direction moves the door closer to the edge of the cabinet. You can adjust both the top and bottom hinge to move the doors closer together or further apart. If you loosen screws 2 & 4 the hinge backplate can be moved up or downwards.

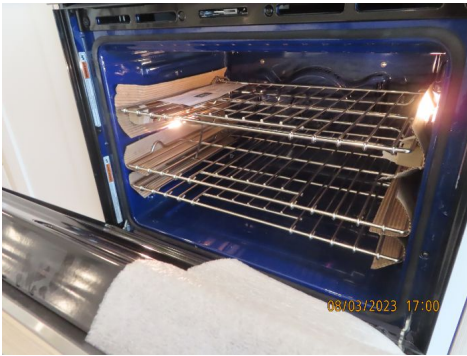
Wall oven

- Did not test, installation is incomplete.

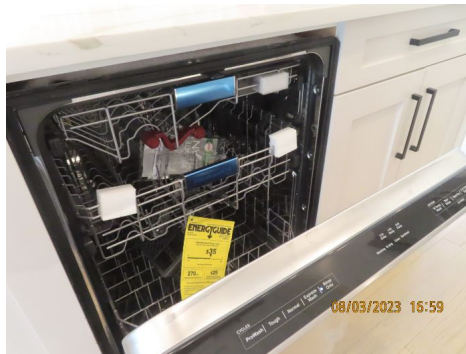
- Installation is incomplete, dishwasher packaging present during inspection.

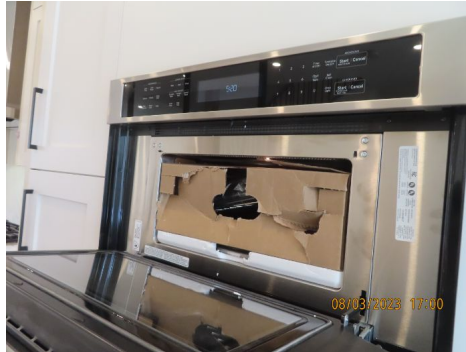
- Inoperable at the time of inspection
- Installation not completed during inspection.

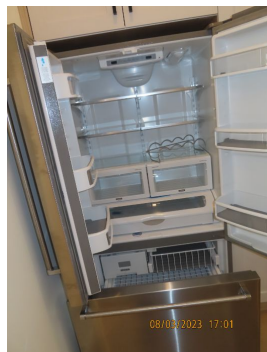
\* Appliance not plugged in/powerd up during inspection.

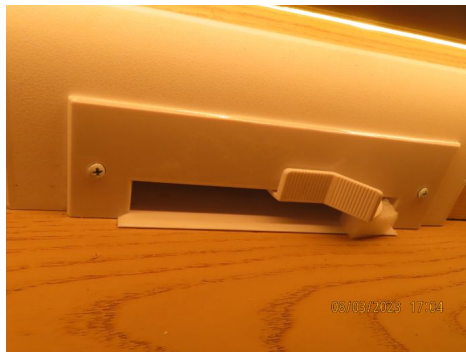
Floor sweep; not functional - no Cental VAC installed

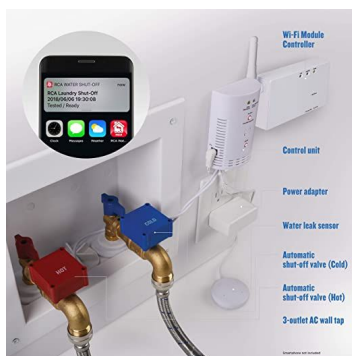
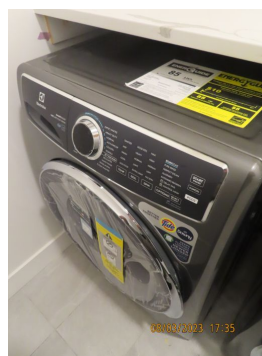
- Installation is incomplete, washer not fully installed at time of inspection.

Recommend larger opening for access to shutoff valves!

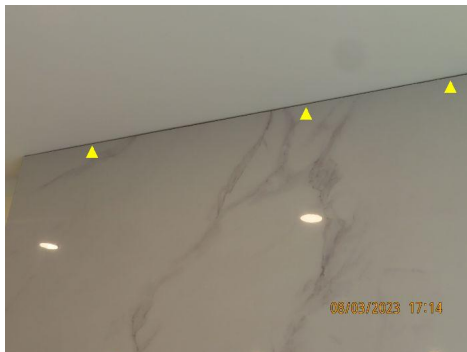
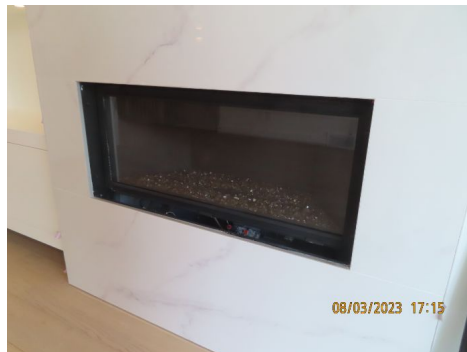
- Not serviceable at time of inspection. Recommend confirming operational prior to possession.
- Pilot light "off" at time of inspection. Lighting of pilot lights is not within the scope of inspection. Buyer is therefore urged to ensure satisfactory operation of this unit prior to close.
- \*Recommend sealing gaps around fireplace
- **CONDITION:** Gaps at top/ around fireplace were observed; Recommend completion.

**CONDITION:** Gaps at top/  
around fireplace were observed;  
Recommend completion.

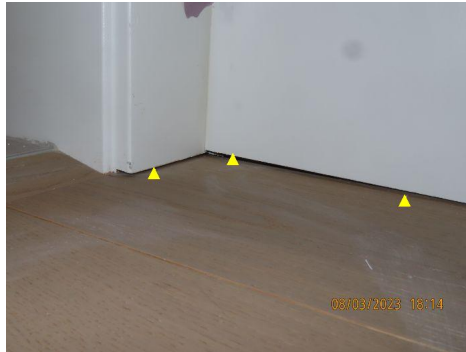
- \* Poor trim work/baseboard noted at 2nd floor closet area.
- \* Recommend repair as necessary.

2nd floor closet; poor trim work

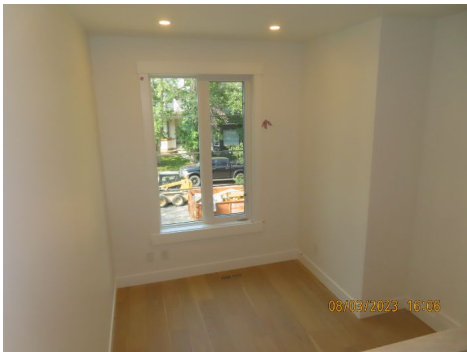
2nd floor

• **CONDITION:** Poor finishing/paint job on wall trim throughout entire areas of the home.

\* We recommend that at walkthrough you take your time to review repairs made prior to possession.

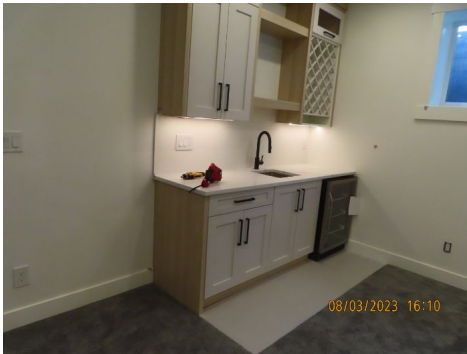
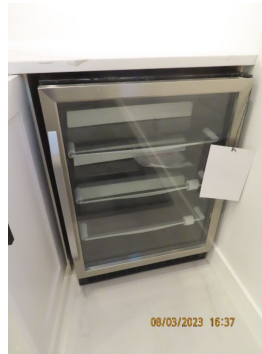
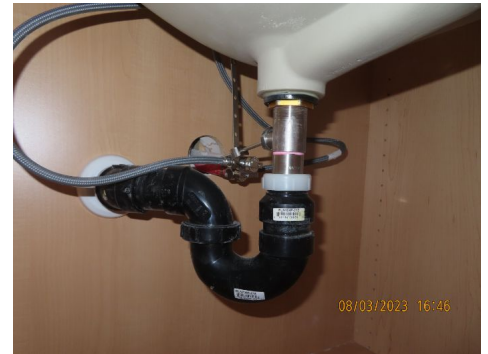
- GFCI receptacle observed near the sink.
- The bar area appears functional at the time of inspection.
- Installation is incomplete.  
Bar fridge not plugged at time of inspection.  
Recommend confirmation appliance working prior to possession.

NO leaks were observed

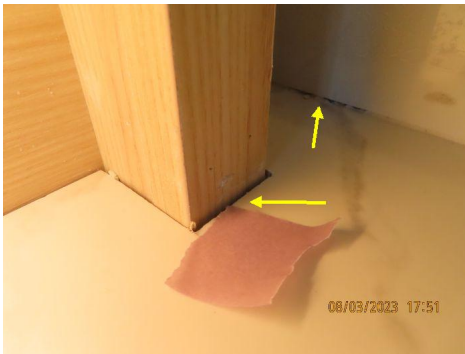
2nd floor bathroom - gaps around cabinetry; should be sealed to prevent moisture penetration into sub-flooring

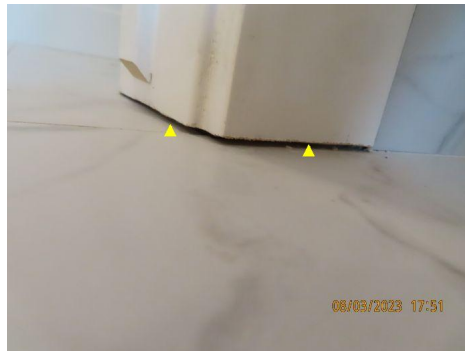
2nd floor bathroom - short trim  
work at door

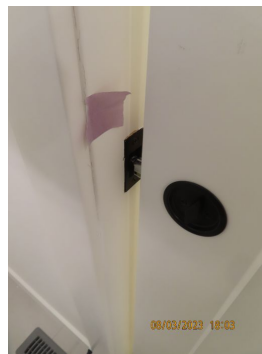
Door does not latch, needs adjustment.  
Location: 2nd floor bath/pocket door

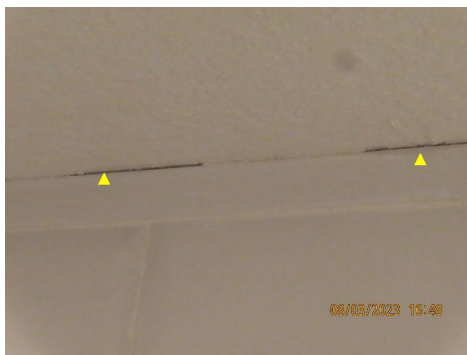
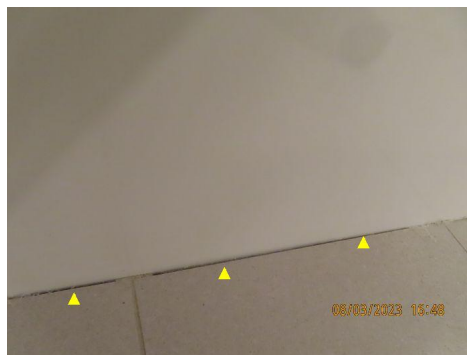
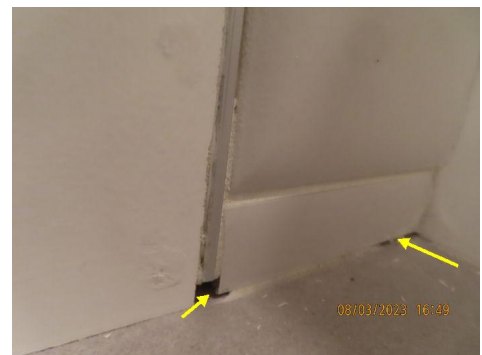
basement bath

- Caulk and/or grout adjacent to tub and shower surrounds should be maintained in good condition to prevent leakage and resulting wall or floor damage. No caulk was installed around tub tile surrounding.

Proper sealing of all of the grout joints is recommended.

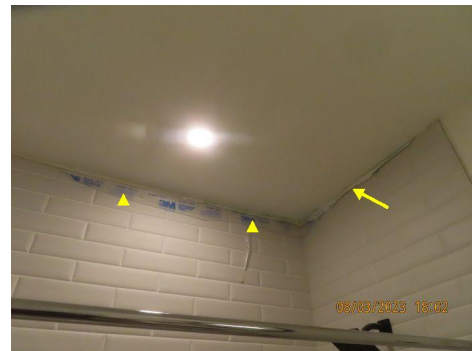
2nd floor main bath - remove tape at top; seal top of tilework

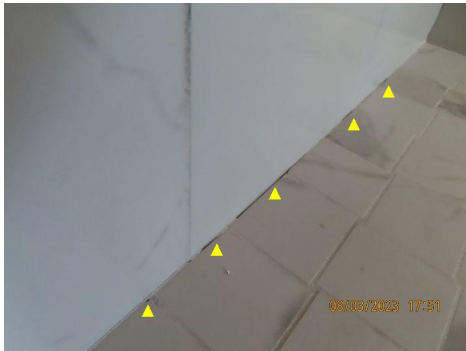
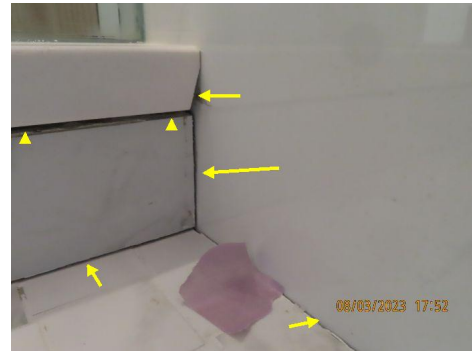
2nd floor ensuite shower base

• **REPAIR: Grout/silicon seal on floor/ tile is missing!**  
 Recommend tile is fully grouted and sealed. appropriately.  
 Monitoring of exterior leaks outside of shower is recommended due to possible water intrusion.

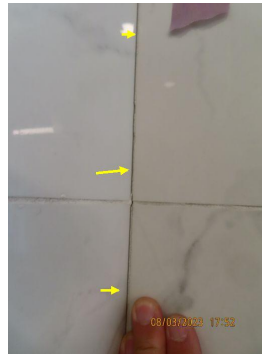
2nd floor ensuite bath: Missing grout/silicon glue seal

- **TIP: Suggest all tile edges and tub/shower walls be caulked and sealed to prevent moisture penetration. All missing/damaged grouting should be replaced. Failure to keep walls sealed can cause deterioration and extensive moisture damage to the interior walls and surrounding sub-flooring.**

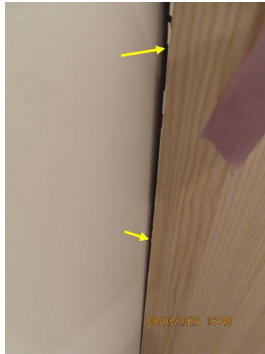
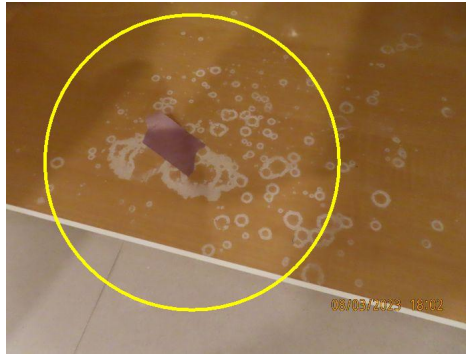
- **CONDITION:** basement bath; large gap where drywall meets cabinetry.  
\* Poor install finishing
- **CONDITION:** There are stains/ water damaged noted inside cabinet area, presumably from past leak(s) or spilled products  
\* location: 2nd floor main bath; recommend replacement

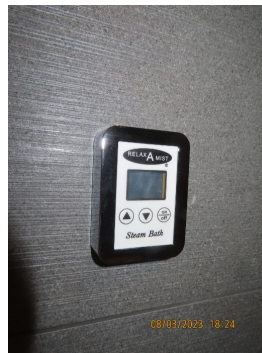
- **Steamer was inoperable at the time of inspection.**  
Location: master en-suite bath

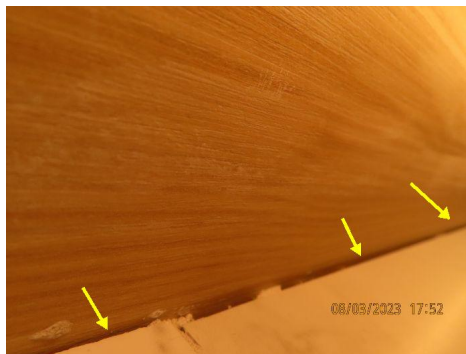
2nd floor en-suite bath/ to cabinetry; gaps present ; recommend sealing with silicon glue

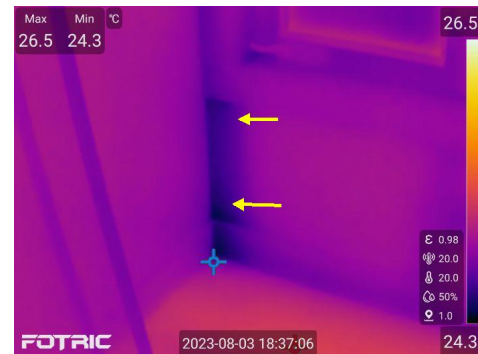
**CONDITION:** The areas were observed with an infrared camera and thermal anomalies consistent with an insulation deficiency (sagging/voids in insulation) or the presence of water/moisture was observed. No elevated reading were observed on a non-invasive moisture meter. Past water intrusion and conceal damages are possible where these condition are observed.

\* Location: 2nd floor front bedroom - left side of window. Further review is advised.

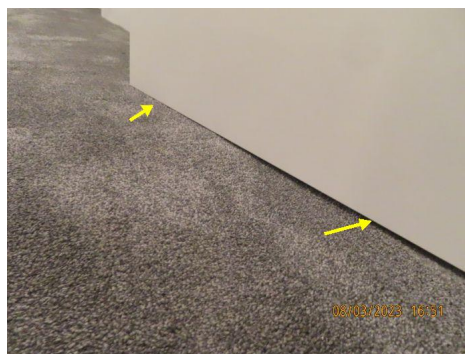
• Door was bind on the jamb and was difficult to close. Requires trimming or adjustment. Recommended correction by qualified contractor.

Basement bedroom - poor installation; door rubs against carpeting

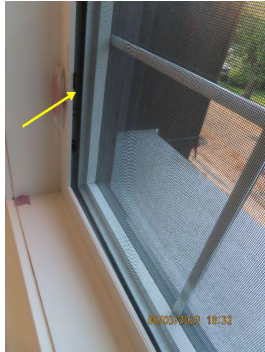
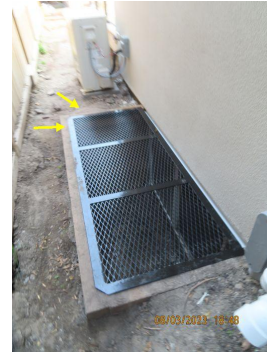
Basement window cover; doesn't fit flush with well well framing; potential fall hazard; recommend repairs for SAFETY.

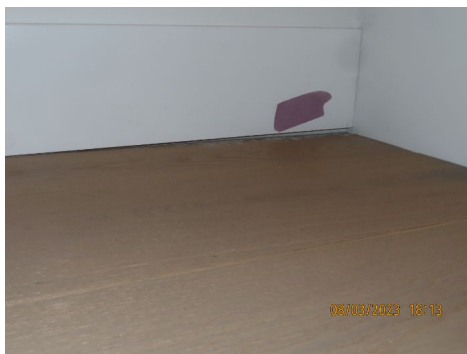
2nd floor closet - poor trim work finishing

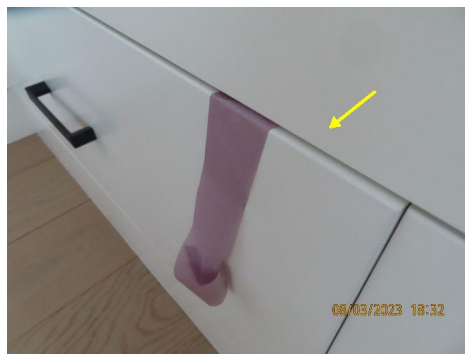
Master bedroom - window drawer - not closing flush

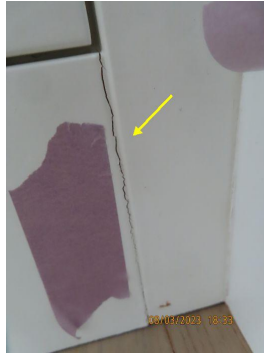
Master bedroom; cracking on finishing noted; recommend repair
